Frost-Proof Wall Hydrant Installation, Use & Repair Guide

Frost Proof Wall Hydrants

Frost Proof Wall Hydrant Installation & Use Guide

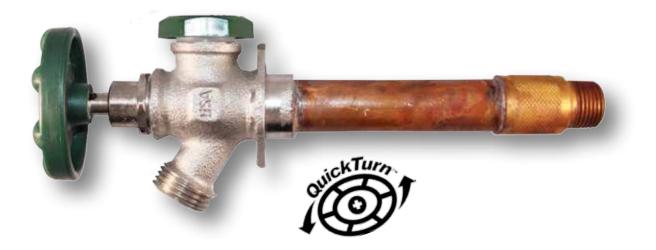
420 Series Anti-Siphon Wall Hydrants

- Frost-Free Hydrants with built-in anti-siphon technology.
- Protects drinking water from harmful contaminates (pesticides, herbicides, etc).
- Protects pipes from freezing & damage.
- Includes QuickTurn® Technology: easy on/off operation without letting go of the handle.
- ASSE 1019 Certified by IAPMO.
- 3-Year Limited Warranty

- Faucet should not be pressurized for more than 12 consecutive hours
- Not designed for constant pressure applications (i.e. sprinkler & drip timers, "Y" Shut offs...)
- When using self-closing nozzle, always relieve pressure after shut-off
- Faucet must be installed at a downward angle to ensure drainage & prevent freezing

- Leaking out of the Weep Hole during use:
 Cause: worn out o-ring on the check assembly. This happens over time or if the faucet is left "ON" for long periods of time (over 12 hrs)
- If the faucet was installed after 1999 OR the stem's check assembly is SPRING-LESS, replace with new check assembly [PK2016] OR full stem

- Cause: worn, broken or missing parts
- Repair by removing old parts & replacing with new parts from kit [PK1430]
- Follow assembly diagram on next page

- Cause: worn out parts & seals
- If the stem has a SPRING in the Check Assembly, the full stem should be replaced with a Special Order Stem Length that is 1/4" longer [PK2004SP -PK2014SP]- OR replace the hydrant

- Cause: worn out washer or broken faucet seat
- Replace the check-assembly or entire stem
- If replacement parts do not work, contact Arrowhead Brass

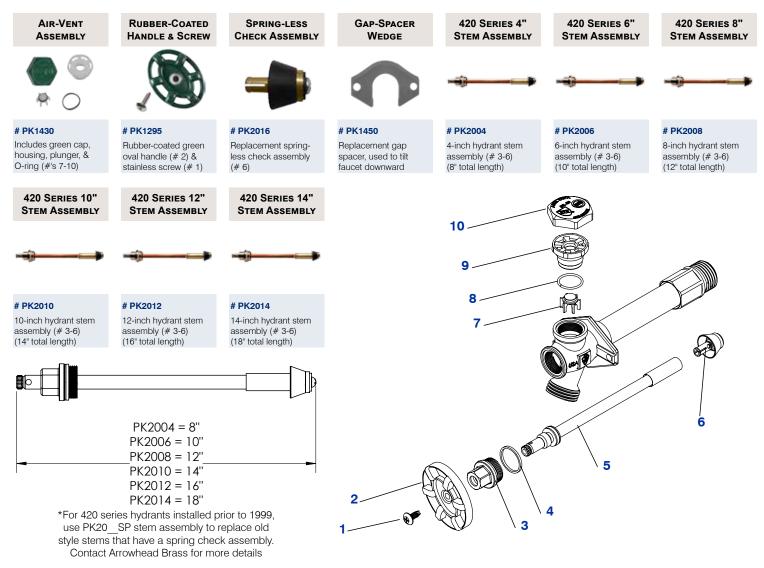
Repair & Replacement Parts

If your faucet stem has a SPRING or does NOT measure to an even length, you may need an "SP" Stem

- SP Stems are 4-1/4" longer than the hydrant length (i.e. PK2004SP = 8-1/4")
- SP Stems should work as replacements for valve older than 1999 but often times may not work. SP or "special" stems
 are non-returnable & not covered under warranty
- Arrowhead Brass suggests replacing your faucet if it was installed before 2001. We can not guarantee that SP parts will work

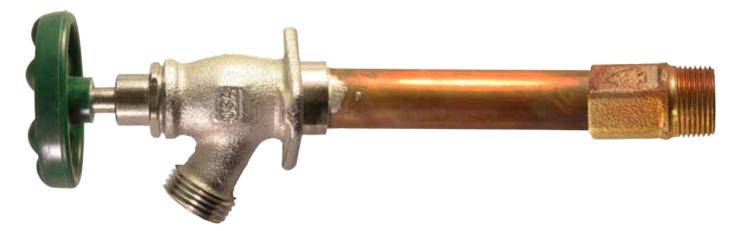
450 Series Standard Frost-Proof Wall Hydrants

- Standard Frost-Free Wall Hydrant
- Protect faucet & pipes from freezing & damage by separating cold weather from water supply
- Made in the USA; 3-Year Limited Warranty
- IMPORTANT: Always shut off faucet after use AND remove hose in order to drain the faucet and prevent freezing
- Faucet should not be pressurized for more than 12 consecutive hours
- Does not provide anti-siphon back-flow protection; add-on devices available (may be required by code)
- Faucet must be installed at a downward angle to ensure drainage & prevent freezing
- When using self-closing nozzle, always relieve pressure after shut-off

- Faucet will not shut off:
- Cause: worn out washer or broken faucet seat
- Replace entire stem [PK8004-PK8014]- suggested
- Replace seat washer & screw at end of the stem [PK1000]
- If new stem does not stop leak, replace the faucet
- If original stem is not a standard length (even lengths 4"-18" total length), special order stems are available

- Cause: loose bonnet or worn out seals in the bonnet.
- If the bonnet has the old 2-piece style with graphite packing, replacing the entire stem is suggested [PK8004-PK8014]
- If the bonnet is the new o-ring style, replacing the stem is suggested [PK8004-PK8014]
- If original stem is not a standard length (even lengths 4-18" total length), special order stems are available

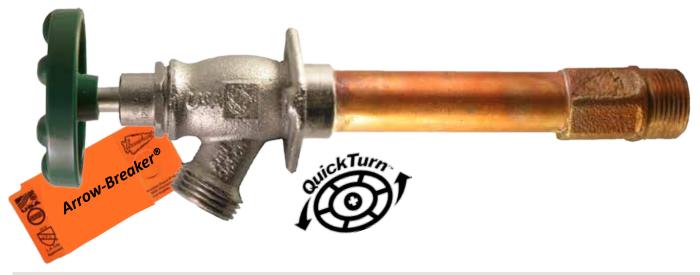
460 Series Arrow-Breaker[®] Frost-Proof Wall Hydrants

- Arrow-Breaker[®] Frost-Free Hydrants with built-in anti-siphon technology
- Protects drinking water from harmful contaminates (pesticides, herbicides, etc)
- Includes QuickTurn® Technology: easy on/off operation without letting go of the handle
- Protects pipes from freezing & damage
- ASSE 1019 Listed; IAPMO Certified
- Made in the USA; 3-Year Limited Warranty

- Faucet should not be pressurized for more than 12 consecutive hours
- Not designed for constant pressure applications (i.e. sprinkler & drip timers, "Y" Shut offs...)
- When using self-closing nozzle, always relieve pressure after shut-off
- Faucet must be installed at a downward angle to ensure drainage & prevent freezing

- Cause: worn out washer or broken faucet seat
- Repair by replacing the Spring-Less Check Assembly (PK6026) or replacing the entire stem assembly (PK6004-PK6014)
- If faucet continues to leak when OFF, the faucet seat might be broken and the faucet will need to be replaced

- Cause: loose bonnet or worn out seals in the bonnet.
- If tightening the bonnet does not stop leaking from the threads, replace nylon washer (or the Stem Assembly (PK6004-PK6014)

- Cause: worn out o-ring on the check assembly. This happens over time or if the faucet is left "ON" for long periods of time (over 12 hrs).
- Repair by replacing the Spring-Less Check Assembly (PK6026)
- If the leak still occurs, replace the entire stem assembly (PK6004-PK6014)

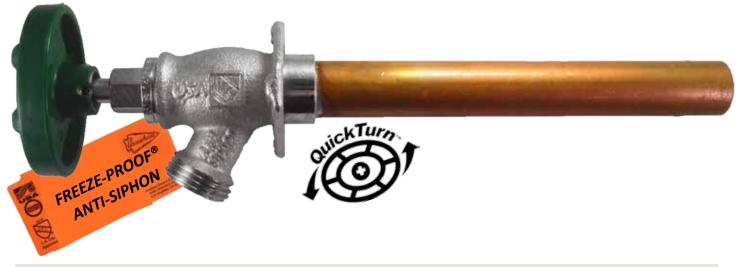
470 Series Freeze-Proof[®] Wall Hydrants

- Revolutionary Freeze-Proof® technology prevents damage from freezing water by reducing pressure build-up
- New innovative o-ring shut off design that prevents damage & wear to hydrant seat
- Maintains constant separation between household and irrigation water sources
- Prevents back-flow by utilizing patented Arrow-Breaker® integrated anti-siphon technology
- QuickTurn® easy on/off operation without letting go of the handle
- ASSE 1019-A Certified

- Max. 140°F 125 PSI
- 3 Year limited warranty; Made in the USA from domestic and foreign components
- Faucet should not be pressurized for more than 12 consecutive hours
- Not designed for constant pressure applications (i.e. sprinkler timers, "Y" Shut offs...)
- Remove hose after use to drain faucet
- When using self-closing nozzle, always relieve pressure after shut-off
- Faucet must be installed at a downward angle to ensure drainage & prevent freezing

- Shut-off water to the hydrant & open it all the way.
- Loosen the bonnet with a wrench and remove stem assembly.
- With the stem removed, briefly turn water supply back on to flush the hydrant, then shut-off again.
- Inspect the stem for cracks or damage to the O-rings or other parts. The recommended repair is to
 replace the Freeze-Proof® check assembly (PK7026) or replace the entire stem (see instructions below to
 identify the stem kit needed PK7004 through PK7014).
- Reinstall stem with bonnet in the open position, close the hydrant and turn water back on to the valve.

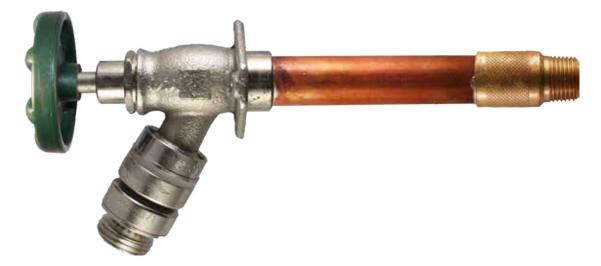
480 Series Self-Draining Frost-Proof Wall Hydrants

- Frost-Free Hydrants with Self-Draining Anti-Siphon Vacuum Breaker
- Protects drinking water from harmful contaminates (pesticides, herbicides, etc)
- Drains water from hydrant upon shut off to protect faucet & pipes from freezing & damage;
- ASSE 1019 Listed; IAPMO Certified
- Made in the USA; 3-Year Limited Warranty

- Faucet should not be pressurized for more than 12 consecutive hours
- Not designed for constant pressure applications (i.e. sprinkler & drip timers, "Y" Shut offs...)
- When using self-closing nozzle, always relieve pressure after shut-off
- Faucet must be installed at a downward angle to ensure drainage & prevent freezing

- Cause: worn out washer or broken faucet seat
- Replace entire stem [PK8004-PK8014]- suggested
- Replace seat washer & screw at end of the stem
- If new stem does not stop leak, replace the faucet
- If original stem is not a standard length (even lengths 4"-18" total length), special order stems are available

- Cause: loose bonnet or worn out seals in the bonnet.
- If the bonnet has the old 2-piece style with graphite packing, replacing the entire stem is suggested [PK8004-PK8014]
- If the bonnet is the new o-ring style, replacing the stem is suggested [PK8004-PK8014]
- If original stem is not a standard length (even lengths 4-18" total length), special order stems are available

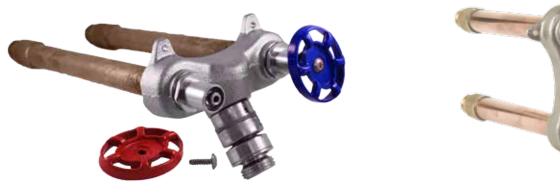
490 Series Hot & Cold **Frost-Proof Wall Hydrants**

- Heavy Pattern Lead-Free Bronze: NSF/ ANSI 372 Certified Lead Free, IAPMO Listed
- Hot & Cold Mixing, with Color Coded Red & Blue Handles
- External Self-Draining Vacuum Breaker: drains hydrant upon shutoff to prevent freezina.
- ASSE 1019-A Approved, IAPMO Certified

- Exclusive O-Ring Bonnet & Stem design
- Includes QuickTurn® style operation: Easy on/off without letting go of the handle
- Rubber coated oval handle
- Dual back-flow protection with internal anti-siphon check valves to prevent mixed temperature back-flow
- Available in 4, 6, 8, 10, 12 & 14 Inch lengths (other lengths available by special order)

- Cause: worn out washer or broken faucet seat
- Repair by replacing the stem assembly
- If faucet continues to leak when OFF, the faucet seat might be broken and the faucet will need to be replaced

- Cause: worn out gasket and seals; happens with ٠ age & use, or when left on/open for long periods of time.
- Fix by replacing fine thread vacuum breaker: 59BFPCHR or PK1390
- Ensure all 3 brass sections of vacuum breaker are removed
- Use liquid thread sealant

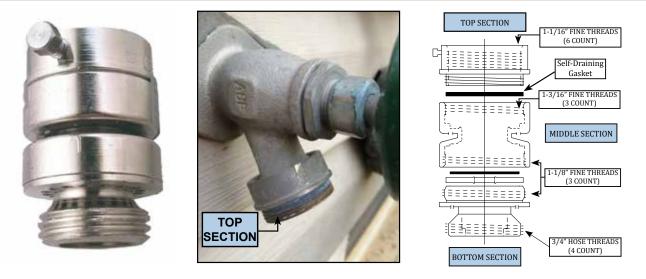
Self-Draining Vacuum Breakers 59 Series / PK1390

- ASSE 1019 back flow preventer
- Protects drinking water from harmful contaminates (pesticides, herbicides, etc)
- Designed to drain the faucet upon shut off to prevent damage from freezing
- Vacuum Breaker should not be pressurized for more than 12 consecutive hours: Not designed for constant pressure applications (i.e. sprinkler & drip timers, "Y" Shut offs...)
- When using self-closing nozzle, always relieve pressure after shut-off
- Faucet must be installed at a downward angle to ensure drainage & prevent freezing
- Water from wall hydrant will drain in a steady gentle stream for approximately 15-20 seconds after hydrant is turned off.
- For optimum freeze protection, vacuum breaker should be installed at an angle towards the ground, device will not work if it is installed completely vertical or horizontal

- Cause: worn out gasket and seals; happens with age & use, or when left on/open for long periods of time.
- Result: Leaks non-stop when on out of holes in "middle Section.

- Fix by replacing fine thread vacuum breaker
- **TOP SECTION MUST BE REMOVED FROM FAUCET**: Ensure the fine thread top section of the original vacuum breaker is removed from the faucet before trying to install replacement. 6 fine threads should be visible. Hold the faucet body in place with channel locks while removing vacuum breaker (with pipe wrench or vise grips) to prevent damage to faucet.

- Use Liquid Thread Sealant (Pipe Dope) on Fine Threads when installing replacement. Without positive thread seal, vacuum breaker
- Set Screw on replacement/new vacuum breakers only. Tighten when installed to prevent removal
 IMPORTANT: After installation, vacuum breaker may need to be pressurized to work correctly: hook up
 a hose with a closed nozzle attached, turn the faucet on FULL BLAST and allow hose to fill. Once filled, the
 vacuum breaker will seal & stop leaking

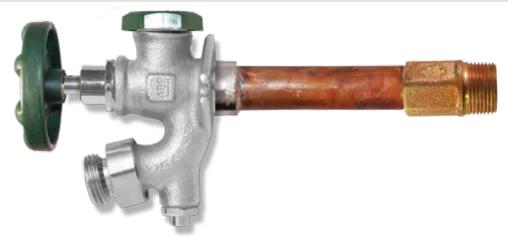
455BFP Series "Apache" Frost-Proof Wall Hydrants

- Anti-Siphon Frost-Free Wall Hydrant
- 455BFP Apache Series- DISCONTINUED IN 2009; hydrant no longer available
- <u>IMPORTANT</u>: Always shut off faucet after use AND remove hose in order to drain the faucet and prevent freezing
- Faucet should not be pressurized for more than 12 consecutive hours
- Not designed for constant pressure applications (i.e. sprinkler & drip timers, "Y" Shut off...)
- When using self-closing nozzle, always relieve pressure after shut-off

- Cause: worn out washer, seals or broken faucet seat
- Replace seat washer & screw at end of the stem [PK1000]
- If repair parts do not stop leak, replace the faucet
- Replacement stems (PK5004-PK5014) are no longer available from Arrowhead Brass

- Cause: worn, broken or missing parts
- Part Kit PK1440 is no longer available.
- Replacement hydrant suggested.

- Cause: worn, broken or missing parts
- Repair by removing old parts & replacing with new parts from kit [PK1430]
- Follow assembly drawing on next page.
- If leak persists, ensure positive seal and cleaned threads; Do not use thread tape

- Cause: worn, broken or missing parts
- Repair by removing old parts & replacing with new parts [58BFPCHR or PK1370]
- Use thread sealant when installing new part

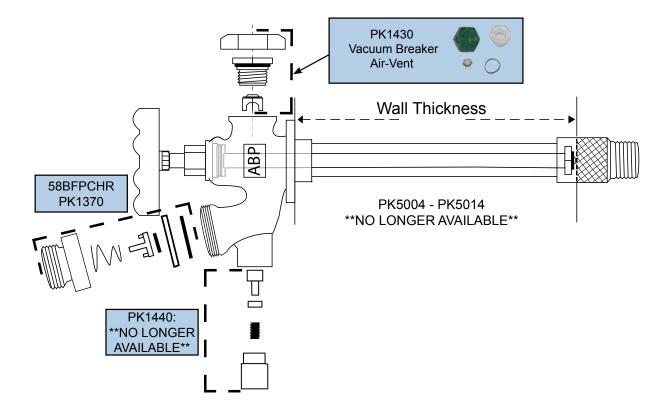
455BFP Series "Apache" Frost-Proof Wall Hydrants

The 455BFP Apache Series has been discontinued since 2008.

Many replacement parts are no longer available. If these parts are required, it is suggested that the Apache series hydrants be replaced with a new hydrant model. Available part kits are below.

PK1000 Seat washer & screw, nylon washer & handle screw

PK1430 Includes green cap, housing, plunger, & O-ring

PK1370 # 58BFPCHR Fine thread nickel plated vacuum breaker-PK- retail package
