OLD Optima® ETF-80/ETF-880

PARTS LIST—ETF-80 AND ETF-880 FAUCETS

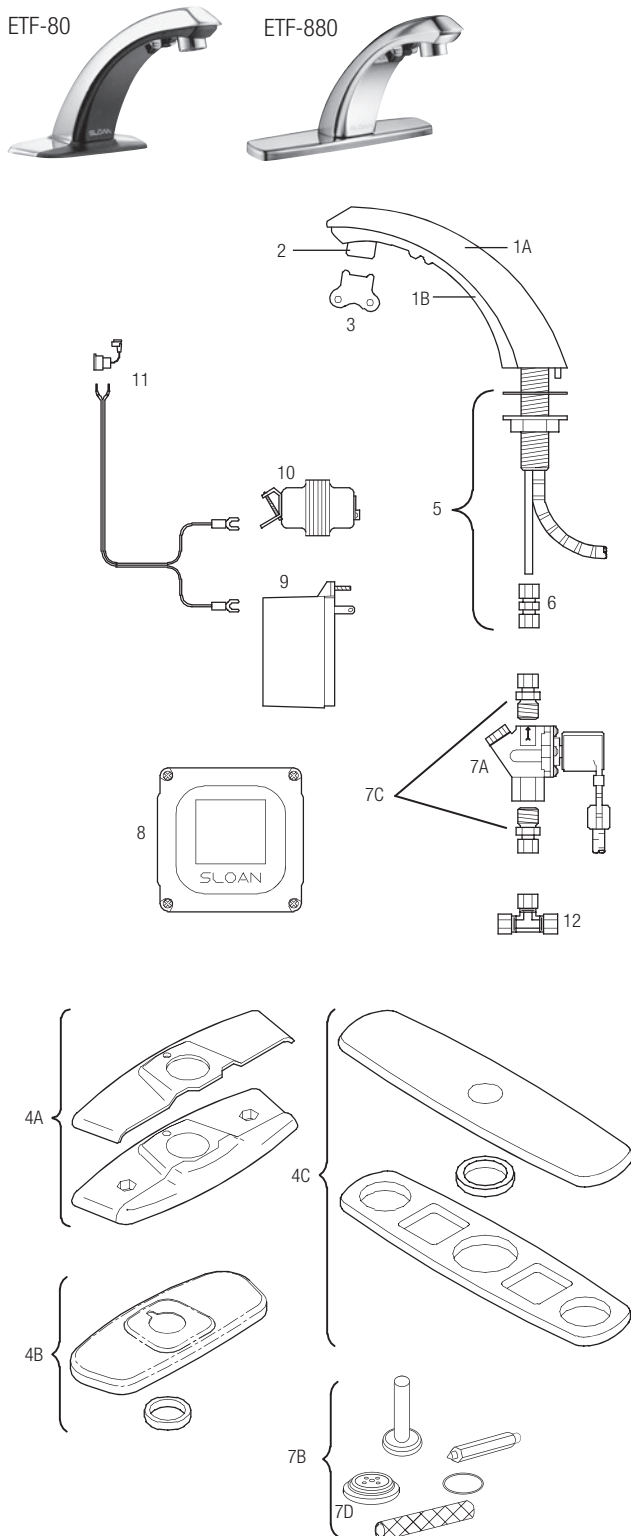
Item No.	Code No.	Part No.	Description
1A.	0305613	ETF-250-A	Faucet/Sensor Assembly (ETF-80)
	0365054	ETF-625-A	Faucet/Sensor Assembly (ETF-880)
1B.	3365523	ETF-631-A	Sensor Assembly Only (for Faucets manufactured after 10/2003, identified by an all white Sloan name on throat plate) (ETF-80). For ETF-80 faucets prior to 10/2003 (identified by a white and red Sloan name on throat plate) sensor assembly discontinued. Use ETF-250 faucet/sensor assembly.
	OBSELETE	ETF-1031	Repair Kit Throat Plate and Sensor (ETF-880)

2.	3365091	ETF-1021-A	0.5 gpm (1.9 Lpm) Spray Head with Key (female thread)
	3365090	ETF-1022-A	2.2 gpm (8.3 Lpm) Aerator Spray Head with Key (female thread)
	3365161	ETF-1028-A	1.5 gpm (5.7 Lpm) Laminar Flow Spray Head with Key (female thread)
	3365755	ETF-1038-A	0.35 gpm (1.3 Lpm) Multi-Lam Spray Head VR

3.	0305927	ETF-435	Replacement Key ONLY
4A.	3365466	ETF-295-A	4" (102 mm) Centerset Trim Plate Kit for Faucet (Faucet Only) includes two (2) Nuts, two (2) Hex Screws, two (2) Flat Washers, Single Hole Cover Plate, and CP Base Plate (ETF-80)
—	3365467	ETF-299-A	4" (102 mm) Centerset Trim Plate Kit for Faucet with Optional Mixing Valve includes two (2) Nuts, two (2) Hex Screws, two (2) Flat Washers, Dual Hole Cover Plate, and CP Base Plate (ETF-80)
4B.	3365473	ETF-662-A	4" (102 mm) Centerset Trim Plate Kit (CP) (ETF-880)
4C.	3365024	ETF-510-A	8" (203 mm) Centerset Trim Plate Kit includes two (2) Finger Nuts, two (2) Washer Gaskets, two (2) Fender Washers, Base Gasket, Back-up Spacer and CP Single Hole Trim Plate Assembly (CP) (ETF-880)

5.	0305626	ETF-290-A	Faucet Mounting Kit includes Rubber Gasket, Mounting Washer, Mounting Nut, and 4439071 Compression Fitting Connector
6.	0305736	ETF-297	1/4" to 3/8" Compression Fitting Connector
7A.	0305849	ETF-370-A	24 VAC Solenoid Valve Assembly includes 18" (457 mm) armored Cable and two (2) Terminal Housings
7B.	3305577	ETF-1009-A	Solenoid Valve Repair Kit includes Replacement Filter, Guide, Armature Spring, Diaphragm and Washer
7C.	3365676	ETF-437-A	Single Solenoid Supply Kit includes, two (2) Compression Fittings (Supplied only with complete faucet)
7D.	3375003	MCR-1003-A	Diaphragm only

8.	3365000	ETF-450-A	Control Module Assembly includes splashproof Junction Box and Junction Box Mounting Kit
9.	0365534	ETF-233	120V/35VA Plug-In Transformer

10.	0345370	EL-248-40	24V/40 VA Box Mount Transformer
11.	0365001	ETF-458-A	Input Power Cable (Transformer to Control Module) includes Strain Relief and two (2) Terminal Crimp Connectors

12.	3365461	ETF-617-A	Bak-Chek® Tee Assembly
—	3305560	ETF-1006-A	Repair Kit for old-style ETF-80 Faucets (manufactured before 1992) includes Hex Screw, 5/64" Hex Wrench, Cable Assembly, Hose Clamp, 5-connector Housing, Key for Spray Heads, Access Plate/Sensor Assembly, and Control Module Assembly — OBSELETE
