420 Series Anti-Siphon Wall Hydrants

Repair & Replacement Parts

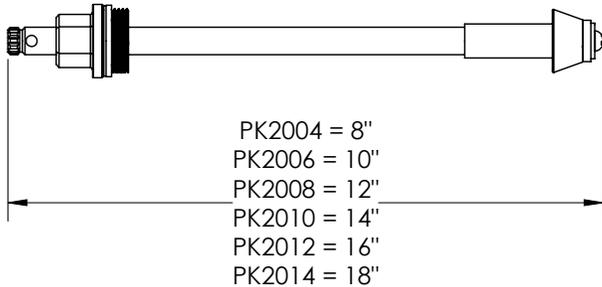
AIR-VENT ASSEMBLY	RUBBER-COATED HANDLE & SCREW	SPRING-LESS CHECK ASSEMBLY	GAP-SPACER WEDGE	420 SERIES 4" STEM ASSEMBLY	420 SERIES 6" STEM ASSEMBLY	420 SERIES 8" STEM ASSEMBLY
# PK1430 Includes green cap, housing, plunger, & O-ring (#'s 7-10)	# PK1295 Rubber-coated green oval handle (# 2) & stainless screw (# 1)	# PK2016 Replacement spring-less check assembly (# 6)	# PK1450 Replacement gap spacer, used to tilt faucet downward	# PK2004 4-inch hydrant stem assembly (# 3-6) (8" total length)	# PK2006 6-inch hydrant stem assembly (# 3-6) (10" total length)	# PK2008 8-inch hydrant stem assembly (# 3-6) (12" total length)

420 SERIES 10" STEM ASSEMBLY	420 SERIES 12" STEM ASSEMBLY	420 SERIES 14" STEM ASSEMBLY
# PK2010 10-inch hydrant stem assembly (# 3-6) (14" total length)	# PK2012 12-inch hydrant stem assembly (# 3-6) (16" total length)	# PK2014 14-inch hydrant stem assembly (# 3-6) (18" total length)

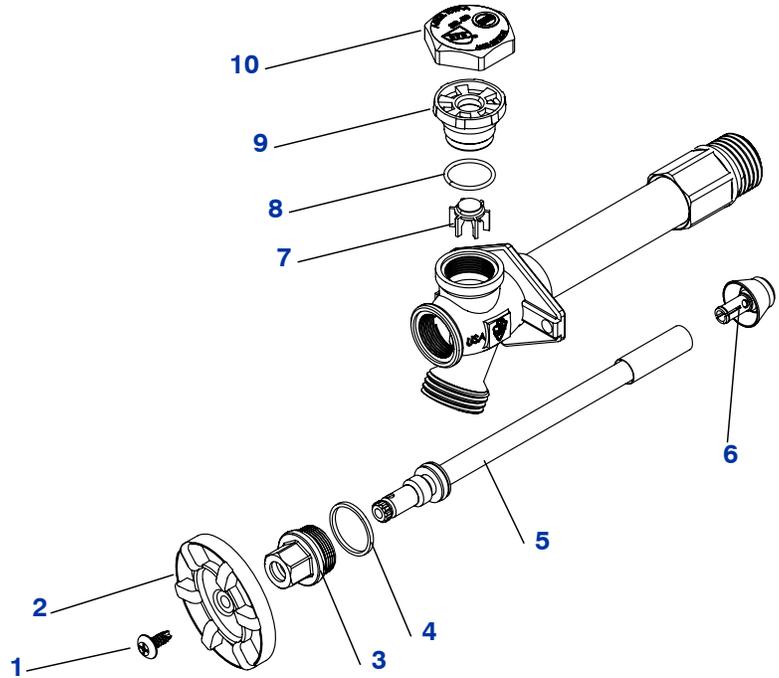
If your faucet stem has a SPRING or does NOT measure to an even length, you may need an "SP" Stem

- SP Stems are 4-1/4" longer than the hydrant length (i.e. PK2004SP = 8-1/4")
- SP Stems should work as replacements for valve older than 1999 but often times may not work. SP or "special" stems are non-returnable & not covered under warranty
- Arrowhead Brass suggests replacing your faucet if it was installed before 2001. We can not guarantee that SP parts will work

*For 420 series hydrants installed prior to 1999, use PK20_ SP stem assembly to replace old style stems that have a spring check assembly. Contact Arrowhead Brass for more details
