Regal® Flushometer

NOTE: Also for use with Regal® XL
(Since mid-2010)

PARTS LIST

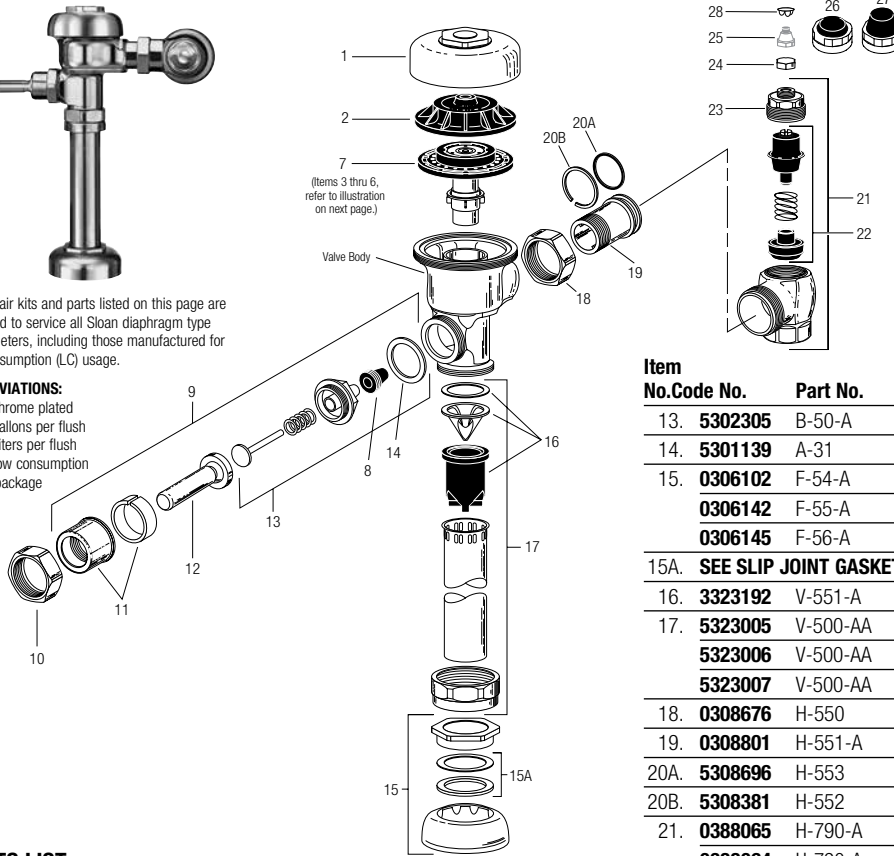
The repair kits and parts listed on this page are designed to service all Sloan diaphragm type flushometers, including those manufactured for low consumption (LC) usage.

Item No.	Code No.	Part No.	Description
1.	0317004	R-10	CP Cover
	—	R-10-HE	CP High Efficiency Cover
2.	0301168	A-71	Inside Cover
SEE ITEMS 3A THROUGH 6E IN CHART ON NEXT PAGE			
3A.	5301058	A-19-AC	Relief Valve, White (Closet) – 12 per package
3B.	5301059	A-19-AU	Relief Valve, Black (Urinal) – 12 per package
3C.	5301211	A-19-ALC	Relief Valve, Green (Closet/Urinal-LC) – 12 per package
3D.	0301143	A-19-AL	Relief Valve, Blue (9 Liter Closet)

4.	5301111	A-15-A	Disc – for all Inside Parts Kits – 12 per package
5.	5301188	A-156-A	Diaphragm – for all Inside Parts Kits – 12 per package
6A.	5301236	A-163-A	Guide Assembly 4.5 gpf/17.0 Lpf Closet & 1.5 gpf/5.7 Lpf Urinal – 12 per package
6B.	5301032	A-152-A	Guide Assembly 3.5 gpf/13.2 Lpf Closet – 12 per package
6C.	5301031	A-151-A	Guide Assembly 1.6 gpf/6.0 Lpf LC Closet – 12 per package
6D.	5301155	A-155-A	Guide Assembly 1.0 gpf/3.8 Lpf LC Urinal – 12 per package
6E.	5301157	A-157-A	Guide Assembly 0.5 gpf/1.9 Lpf Urinal – 12 per package

7.	SEE INSIDE PARTS KITS CHART ON NEXT PAGE		
8.	5302297	B-39	Seal – 12 per package
9.	5302279	B-32-A	CP Handle Assembly – 6 per package
	0302390	B-73-A	CP Handicap Handle Assembly (ADA Compliant)

10.	0301082	A-6	CP Handle Coupling
11.	0302109	B-7-A	CP Socket Assembly
12.	5302274	B-32	CP Handle Grip – 12 per package
	0302389	B-74-A	CP Handicap Handle Grip (ADA Compliant)

Item No.	Code No.	Part No.	Description
13.	5302305	B-50-A	Handle Repair Kit – 6 per package
14.	5301139	A-31	Handle Gasket – 48 per package
15.	0306102	F-54-A	3/4" CP Spud Coupling Assembly
	0306142	F-55-A	1-1/4" CP Spud Coupling Assembly
	0306145	F-56-A	1-1/2" CP Spud Coupling Assembly
15A.	SEE SLIP JOINT GASKETS AND RINGS TABLE BELOW

16.	3323192	V-551-A	Vacuum Breaker Repair Kit
17.	5323005	V-500-AA	3/4" x 9" CP Vacuum Breaker – 6 per package
	5323006	V-500-AA	1-1/4" x 9" CP Vacuum Breaker – 6 per package
	5323007	V-500-AA	1-1/2" x 9" CP Vacuum Breaker – 6 per package

18.	0308676	H-550	CP Stop Coupling†
19.	0308801	H-551-A	CP Adjustable Tailpiece 2-1/16" long†
20A.	5308696	H-553	O-ring – 24 per package
20B.	5308381	H-552	Locking ring – 12 per package

21.	0388065	H-790-A	1" Screwdriver Bak-Chek® Stop CP – complete
	0388064	H-790-A	3/4" Screwdriver Bak-Chek® Stop CP – complete
	0388029	H-740-A	1" Screwdriver Bak-Chek® Stop CP – OBSOLETE
	0388031	H-740-A	3/4" Screwdriver Bak-Chek® Stop CP – OBSOLETE

22.	3308853	H-541-ASD	1" Control Stop Repair Kit *
	3308856	H-543-ASD	3/4" Control Stop Repair Kit **
23.	0308612	H-622	CP Bonnet (Current Regal)
	0308991	H-639	CP Bonnet – Pre 2010 Regal Stops*
	0308601	H-538	CP Bonnet ** – OBSOLETE

24.	5388001	H-1012-A	CP Cap – 6 per package VP
25.	5310034	J-2/J-7	Bumper Assembly – 6 per package – OBSOLETE
26.	3308866	H-574	Stop Cap, chrome plated with Seat Bumper (-YO)

27.	3308867	H-576	Stop Cap, chrome plated with Extended Seat Bumper (-YG)
28.	5388002	H-528	Hole Plug
29.	3388015	H-1015	Flow Control Kit (HEU Only) (not Shown)

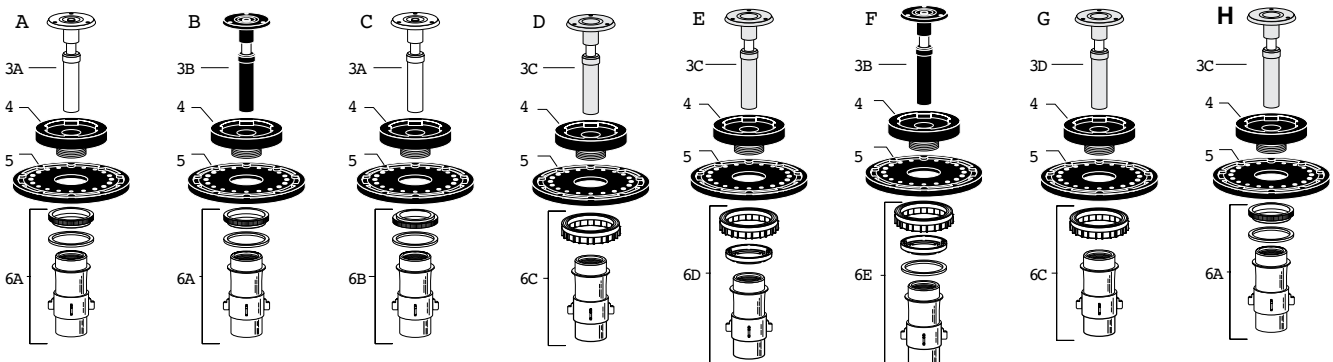
ITEM 7. INSIDE PARTS KITS (SEE ILLUSTRATIONS BELOW)

Item No.	Code No.	Part No.	Application
A.	3301036	A-36-A	4.5 gpf/17.0 Lpf - Closet
B.	3301037	A-37-A	1.5 gpf/5.7 Lpf - Urinal
C.	3301038	A-38-A	3.5 gpf/13.2 Lpf - Closet
D.	3301041	A-41-A	1.6 gpf/6.0 Lpf - Closet
E.	3301044	A-42-A	1.0 gpf/3.8 Lpf - Urinal
F.	3301081	A-43-A	0.5 gpf/1.9 Lpf - Urinal
G.	3301024	A-44-A	2.4 gpf/9.0 Lpf - Closet
H.	3301045	A-140-A	1.28 gpf/4.8 Lpf - Closet

ITEM 7. INSIDE PARTS COMPONENTS (SEE ILLUSTRATIONS BELOW)

Item No.	Code No.	Part No.	Description
3A.	5301058	A-19-AC	Relief Valve, White (Closet) – 12 per pkg.
3B.	5301059	A-19-AU	Relief Valve, Black (Urinal) – 12 per pkg.
3C.	5301211	A-19-ALC	Relief Valve, Green (Closet/Urinal-LC) – 12 per pkg.
3D.	0301143	A-19-AL	Relief Valve, Blue (9 Liter Closet)
4.	5301111	A-15-A	Disc – for all Inside Parts Kits – 12 per pkg.
5.	5301188	A-156-A	Diaphragm – for all Inside Parts Kits – 12 per pkg.
6A.	5301236	A-163-A	Guide Assembly 4.5 gpf/17.0 Lpf Closet & 1.5 gpf/5.7 Lpf Urinal – 12 per package
6B.	5301032	A-152-A	Guide Assembly 3.5 gpf/13.2 Lpf Closet – 12 per package
6C.	5301031	A-151-A	Guide Assembly 1.6 gpf/6.0 Lpf LC Closet – 12 per package
6D.	5301155	A-155-A	Guide Assembly 1.0 gpf/3.8 Lpf LC Urinal – 12 per package
6E.	5301157	A-157-A	Guide Assembly 0.5 gpf/1.9 Lpf Urinal – 12 per package
